## ELASTIC PITCH BEAM TAIL ROTOR

Kaman Aerospace Corporation  
Bloomfield, Conn. 06002

December 1976

Final Report for Period August 1971 - April 1976

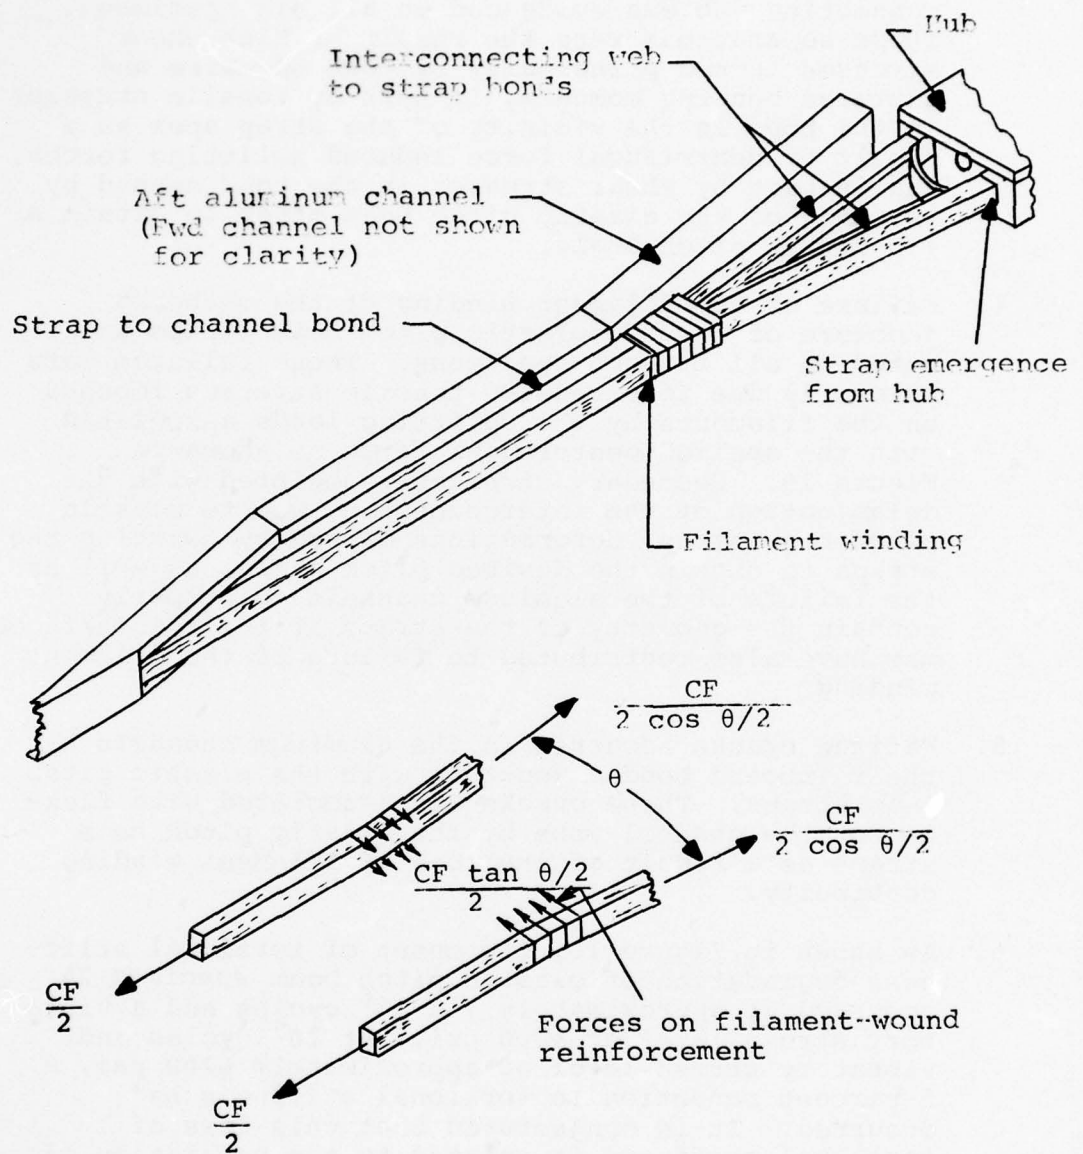
Figure 19. Elastic pitch beam critical areas.

The critical areas of the unidirectional 1002-1014S glass elastic pitch beam straps that were closely monitored for signs of wear or filament fracture are as illustrated in Figure 19. These critical points are the point of strap

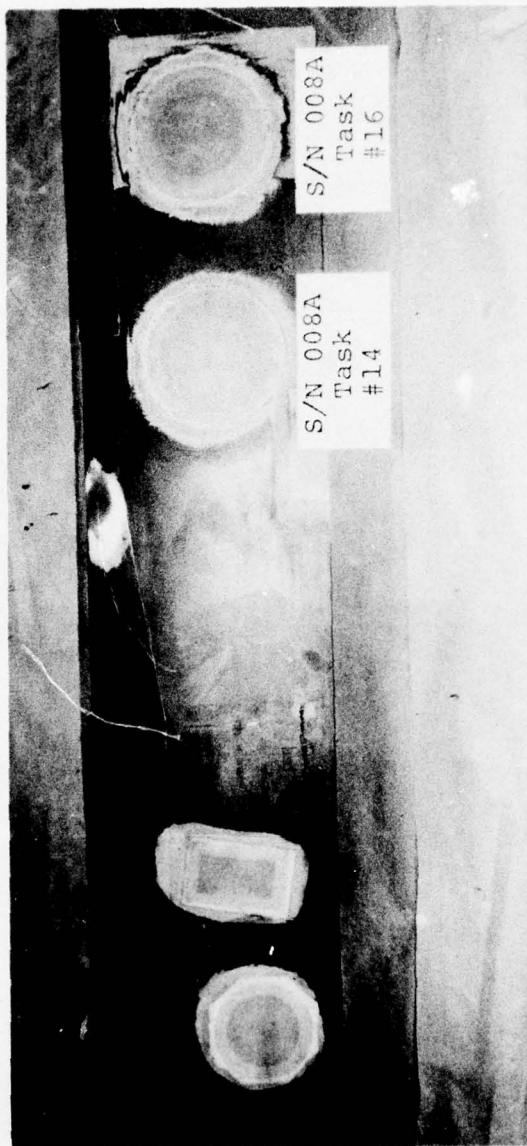
Figure 60. Repaired elastic pitch beam tail rotor blade S/N 008A.

NOTE: Other repair tasks shown, but not identified, in Figures 60 and 61 for blades S/N 008A and S/N 008B respectively were accomplished subsequent to the R&M whirl test program as part of the simulated field service evaluation.

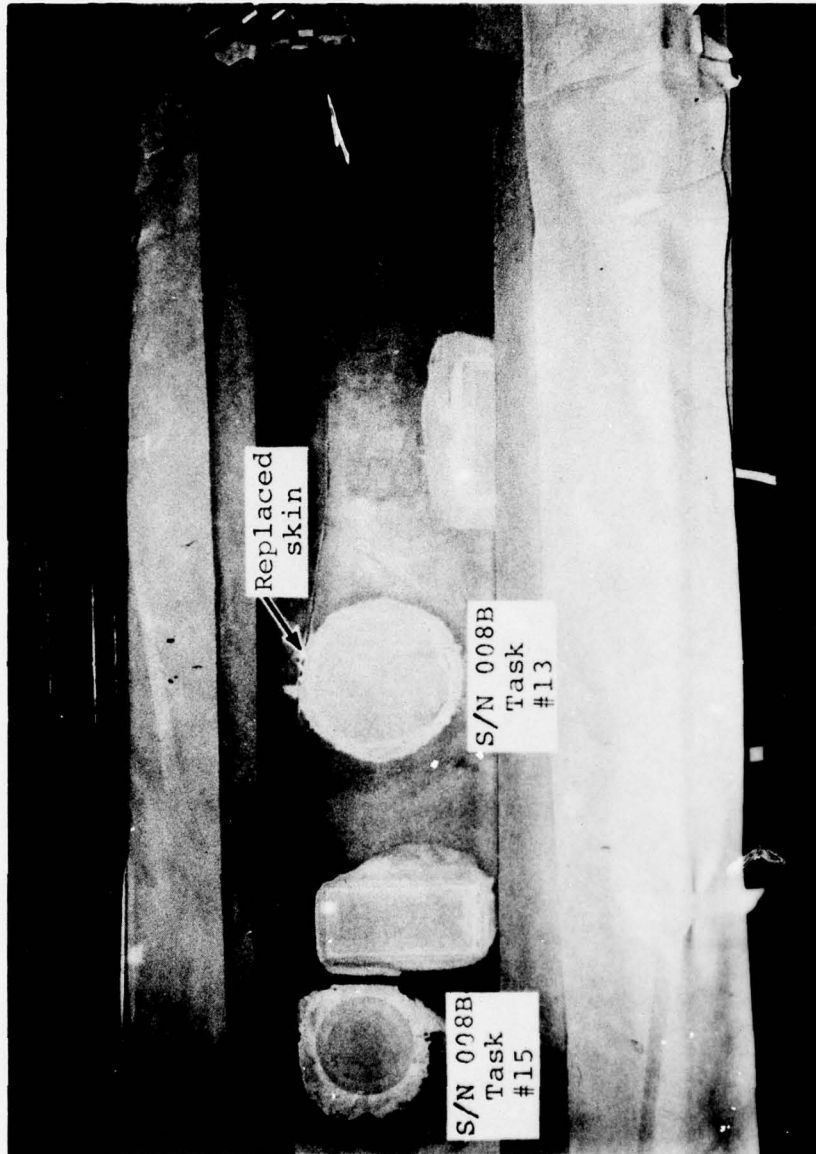
Figure 61. Repaired elastic pitch beam tail rotor blade S/N 008B.

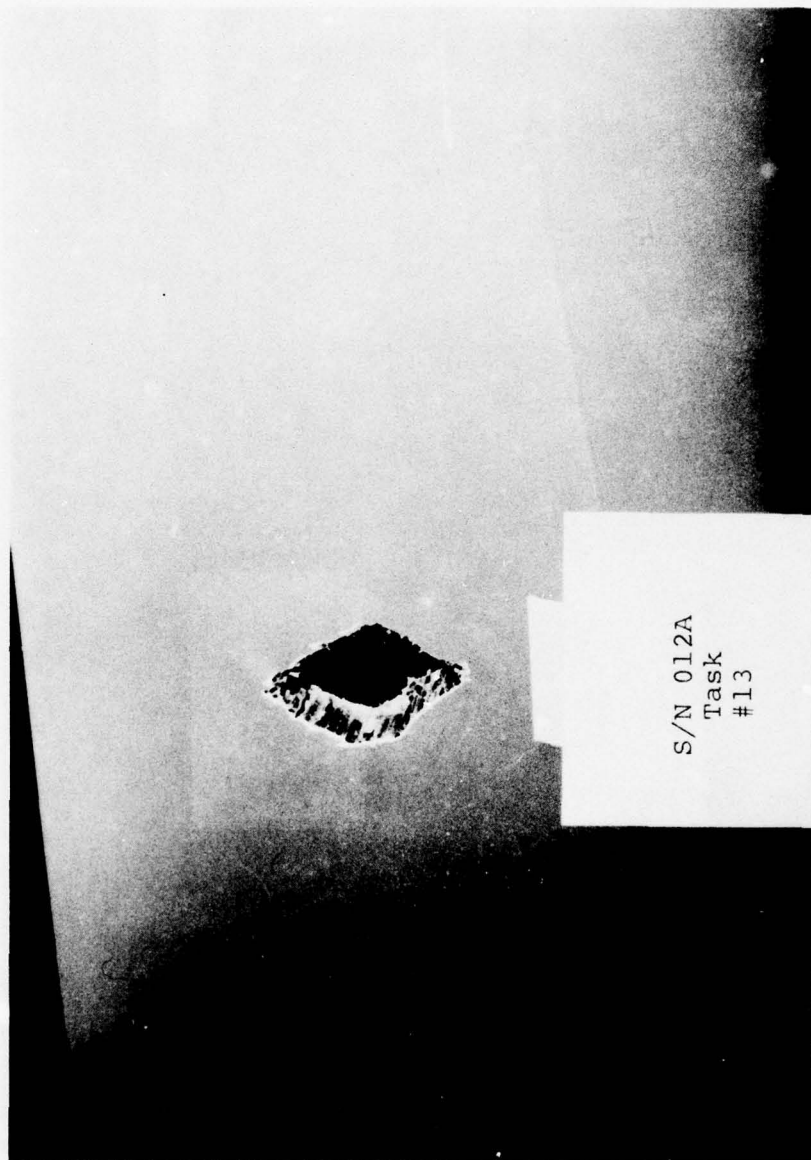
Figure 65. Damaged flight blade specimen.

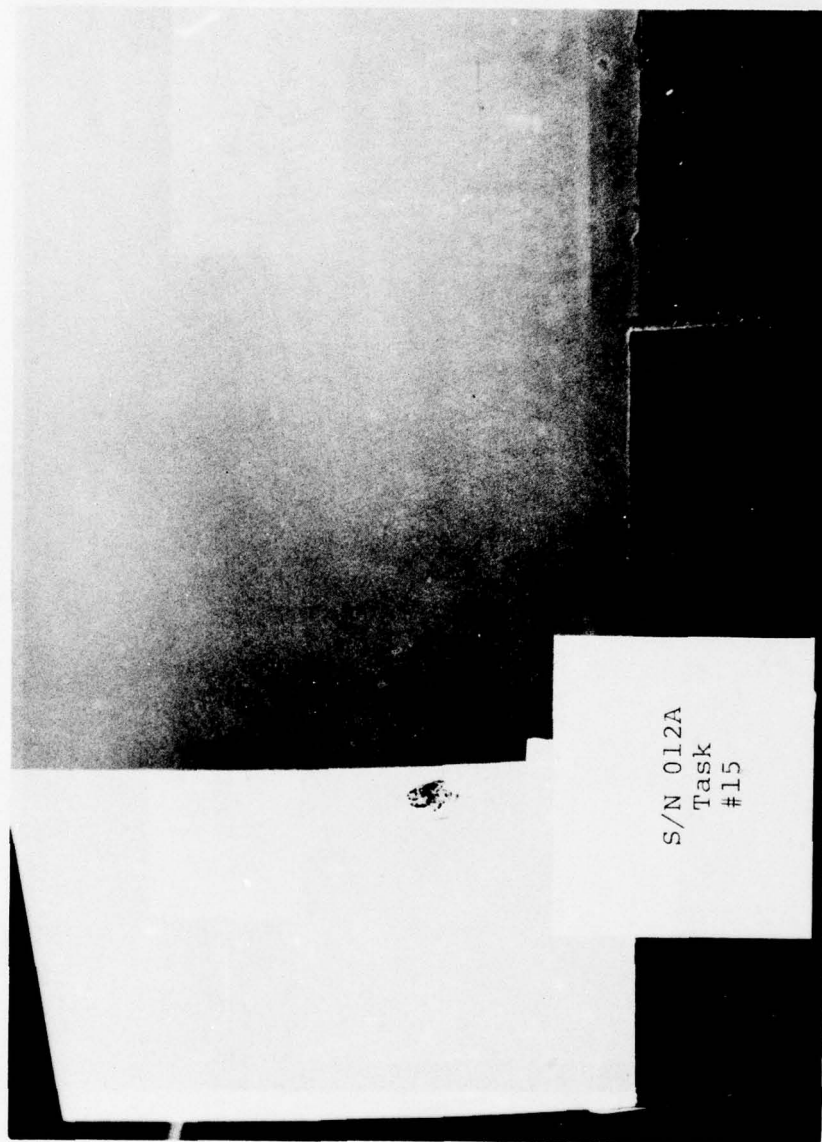
Figure 67. Damaged flight blade specimen, blade punctured.

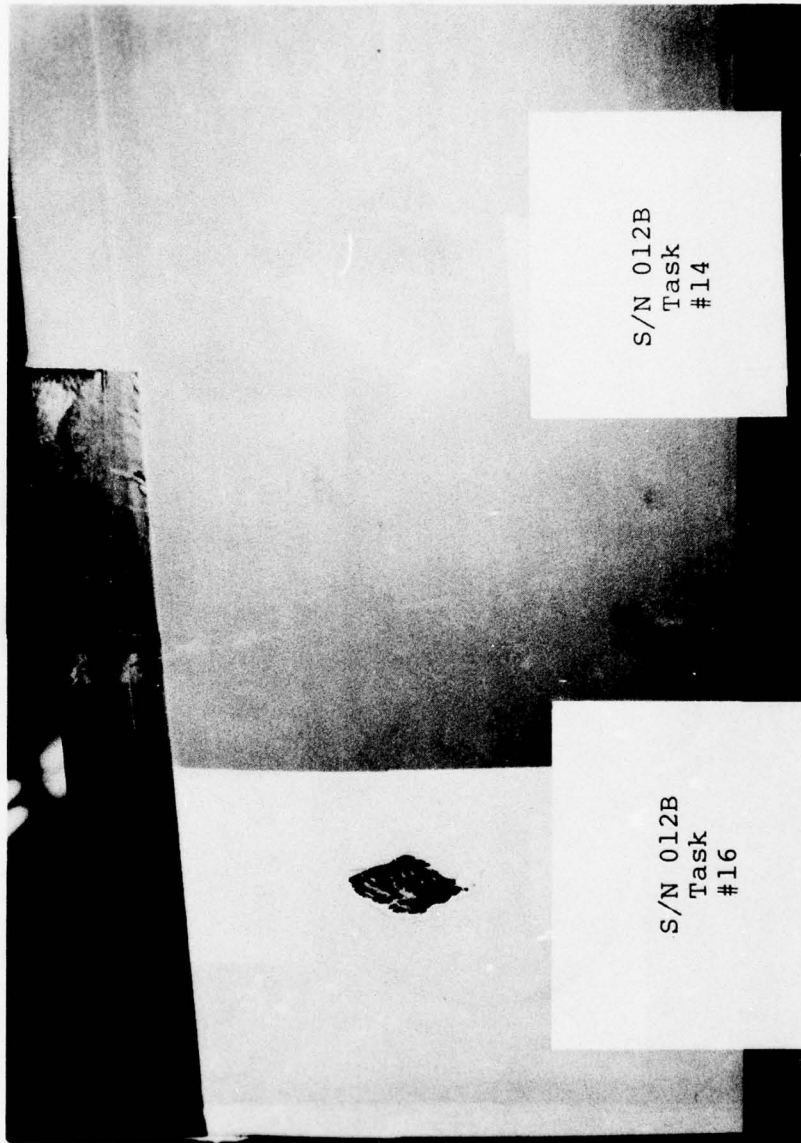
Figure 69. Damaged flight blade specimen, blade punctured and dented.
